Safety Alert

Re: Hoist Near Miss Incident.

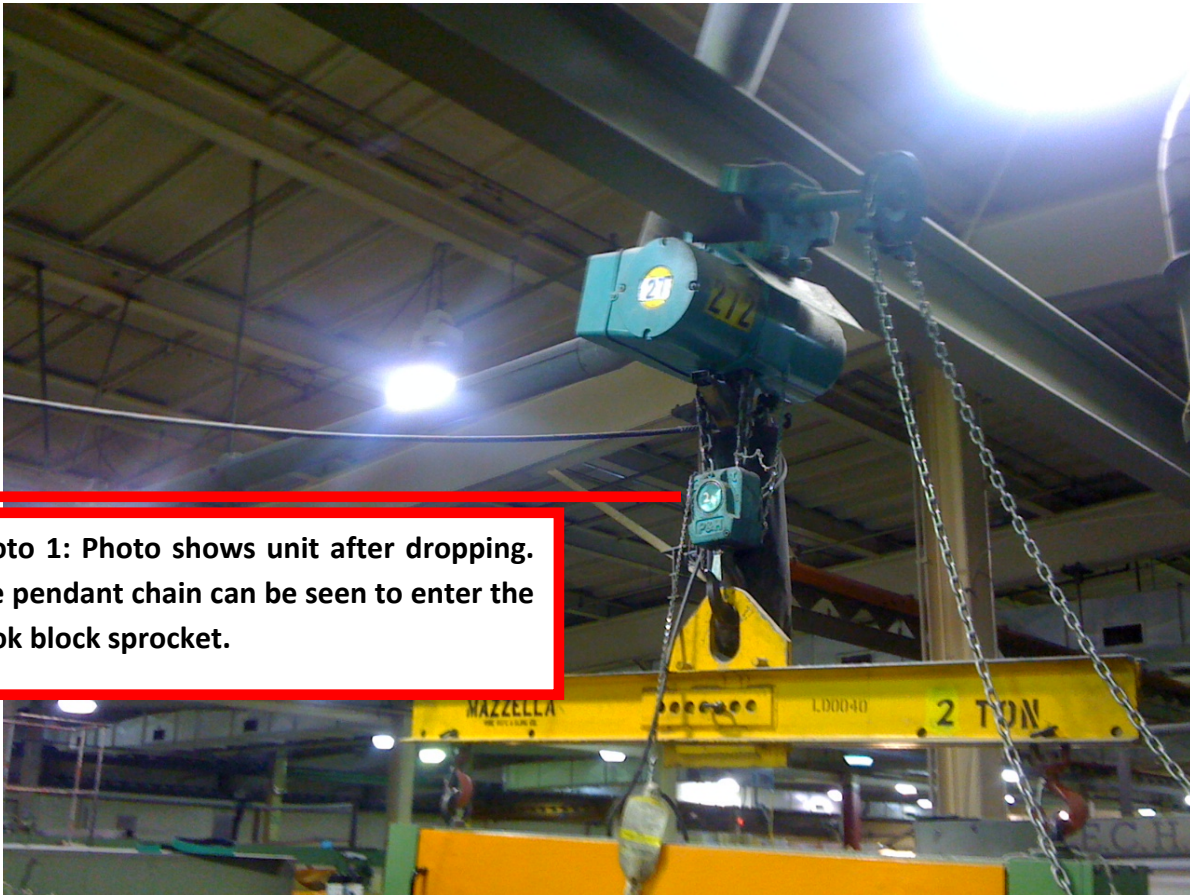
While lifting the Sheeter blade assembly, the monorail hoist suddenly dropped and shifted partially off the rails (photos 1 and 2). Investigation revealed that the control pendant's stress-relief chain had lodged inside of the hook block sprocket. Disassembly of the sprocket and inspection of the area revealed that the stress relief chain had wedged inside the workings of the sprocket (photo 3), causing the incoming chain to slack and then reload. This in turn dropped and shock loaded the unit. The shock load caused the hoist to shift partially off the overhead rail.

Photo 1: Photo shows unit after dropping. The pendant chain can be seen to enter the hook block sprocket.

In response to this incident, the stress-relief chain was replaced with 1/4" coated aircraft cable that cannot enter into the sprocket. In addition, operations personnel were provided refresher training on signs of hoist malfunction, and proper responses. In consideration of this incident, operating areas must review their cranes and hoists for similar control pendant stress-relief chains and, where said chains can enter block sprockets, replace those chains with proper cable.

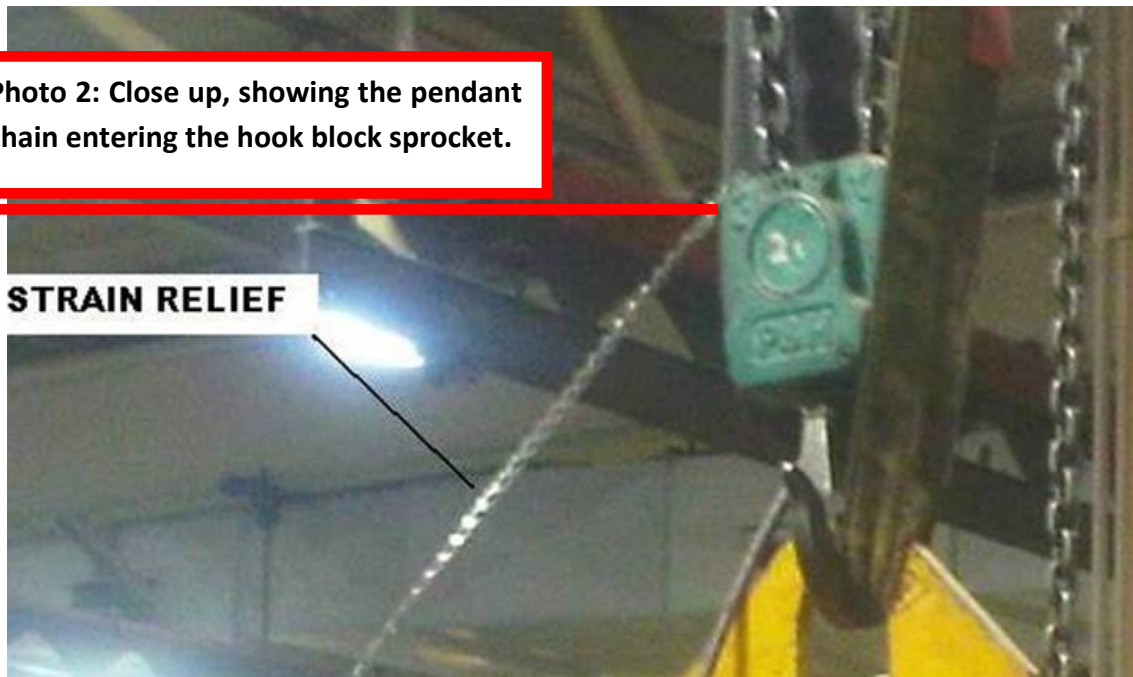
Photo 2: Close up, showing the pendant chain entering the hook block sprocket.

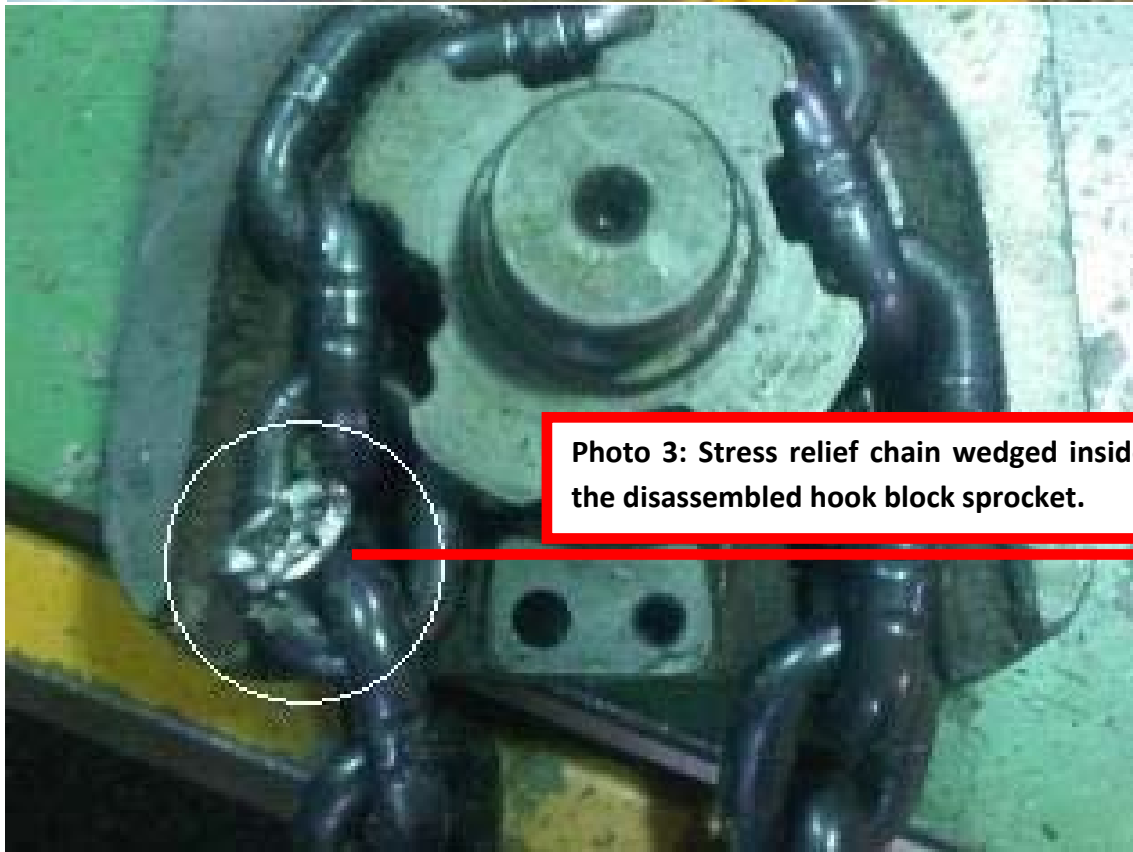
Photo 3: Stress relief chain wedged inside the disassembled hook block sprocket.
